EVALUATION AND DOSIMETRY OF ACCIDENTAL  
EXPOSURES TO AN X-RAY ANALYSIS BEAM.

I.S. Leith and W.A. Cornelius

Australian Radiation Laboratory  
Melbourne, Australia.

(Accidental exposure of two research workers to an X-ray analysis beam during two days resulted in large area burns to the arms and chest. The dosimetry performed was later corroborated by the clinical findings.)

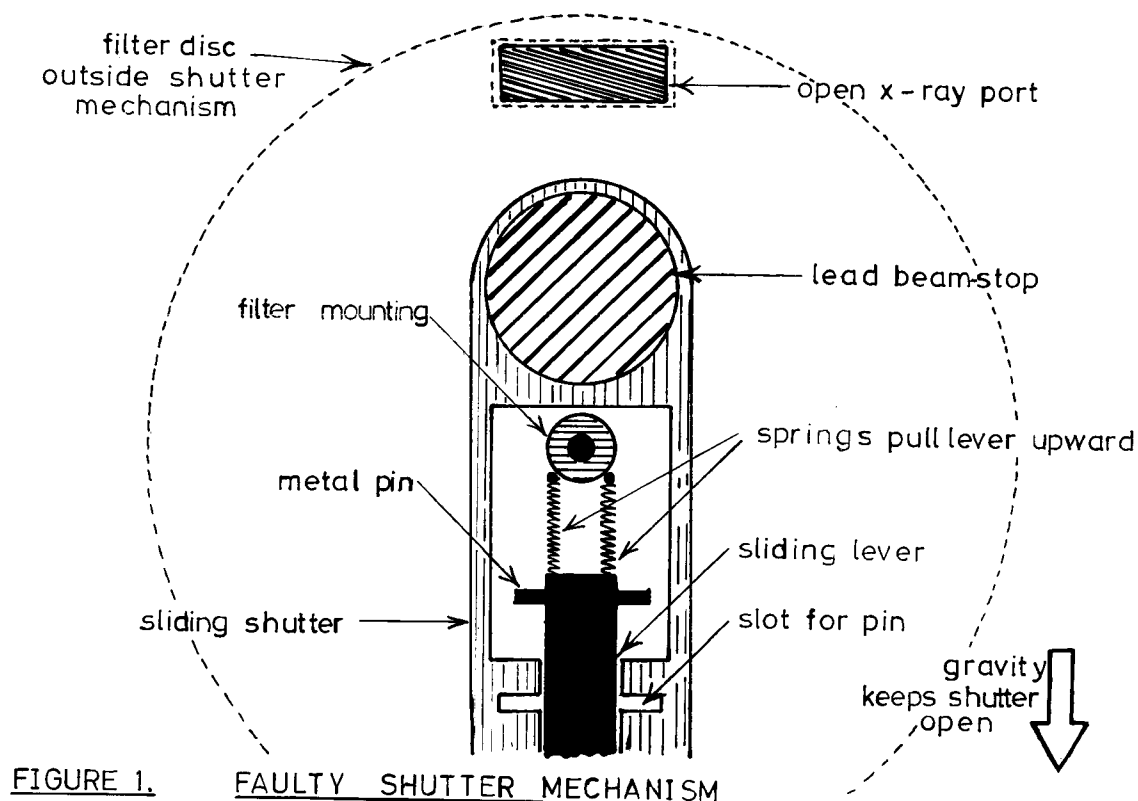
metal pin (see Fig. 1). However, one of these shutter mechanisms had been dis-assembled and re-assembled incorrectly so that the lever no longer engaged the shutter. The shutter then remained permanently open under the force of gravity as illustrated in Figure 1.

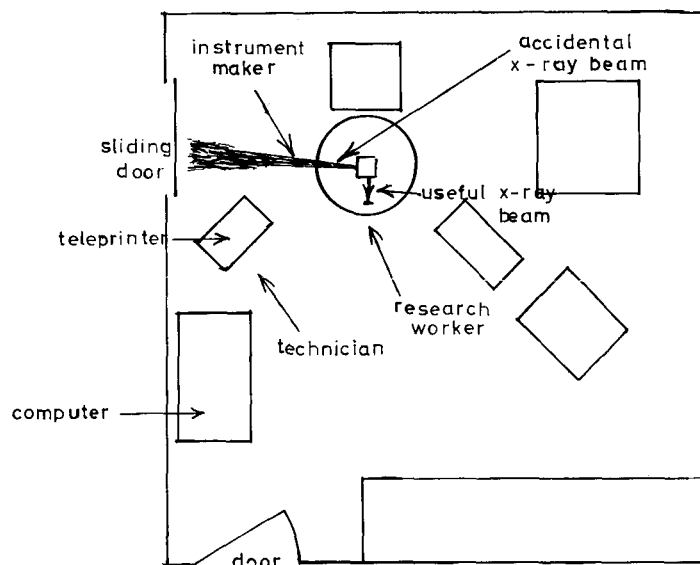
FIGURE 2. DIAGRAM OF X-RAY ROOM

The instrument maker, however, took up a position to the left of the camera he worked with and in this position was directly in line with the beam from the unintentionally open shutter. The beam irradiated his abdomen outside the line of the camera table at a distance of 40 centimetres or more from the open shutter throughout the period in which he worked on the camera. During the following morning, the X-ray unit was energised, using the same operating factors as before, and the instrument maker again attempted to align the camera, from 9 a.m. till 10 a.m. Due to a change of position, he was in the accidental beam for approximately half this period. The X-ray unit was then switched off.

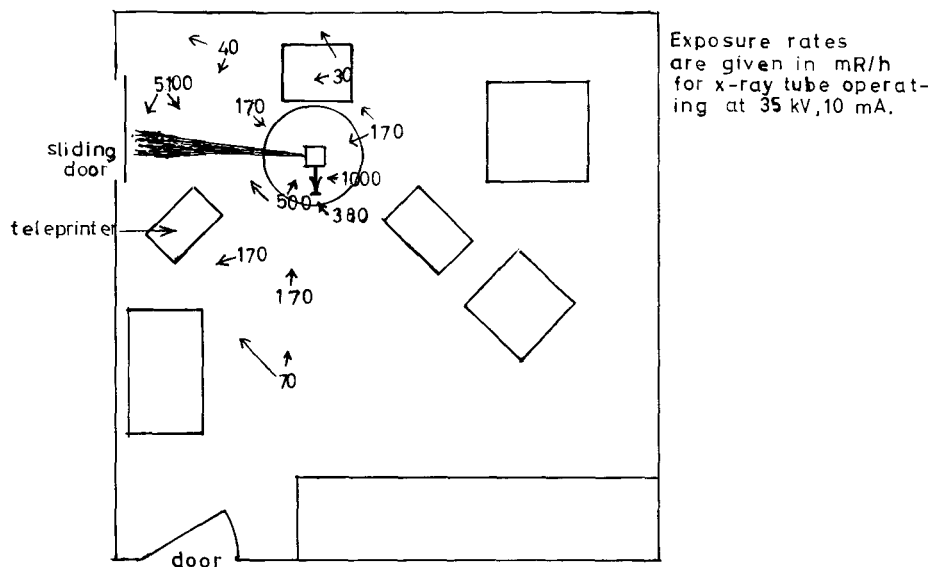
FIGURE 3. EXPOSURE RATES FROM SCATTERED RADIATION

In Figure 3, the scattered radiation exposure-rates measured around the X-ray room are shown.
